Home Inspection Report

Prepared For:
Sample Home Inspection Report

Confidential, Ohio

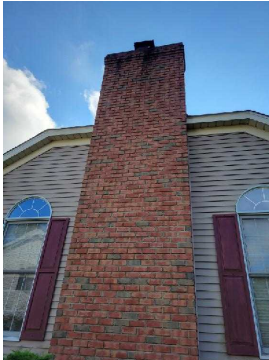
16. Maintenance Chimney: Brick - Chimney crown cracked and should be repaired by a reputable chimney or roofing contractor.

Flue/Flue Cap: Clay - Recommend adding rain/snow cap to round liner at left in picture above in Chimney section.

1. West Chimney Chimney: Brick - **Chimney crown cracked and should be repaired by a reputable chimney or roofing contractor.**

1. West Chimney Flue/Flue Cap: Clay - Recommend adding rain/snow cap to round liner at left in picture above in Chimney section.

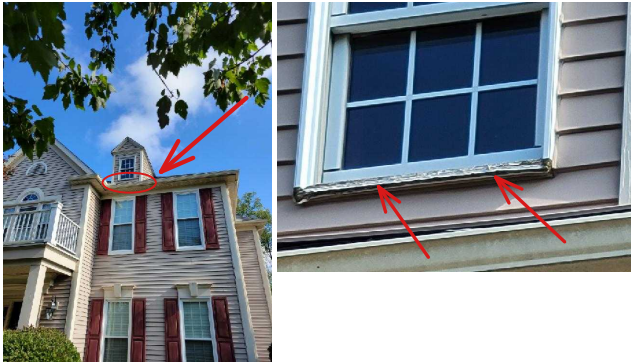
2. Minor Trim, fascia and soffits: Wood - Peeling paint and possible wood rot or damage to the right hand dormer bottom window frame piece shown. Recommend replacing. (Handyman)

2. Trim, fascia and soffits: Wood - Peeling paint and possible wood rot or damage to the right hand dormer bottom window frame piece shown. Recommend replacing. (Handyman)
3. Siding: Aluminum siding - Recommend handyman repair loose siding shown. A yellow jacket nest was inside the upper siding piece so a specialist may be required to remove the nest and its habitants first and then have the siding repaired. (Handyman and pest specialist)

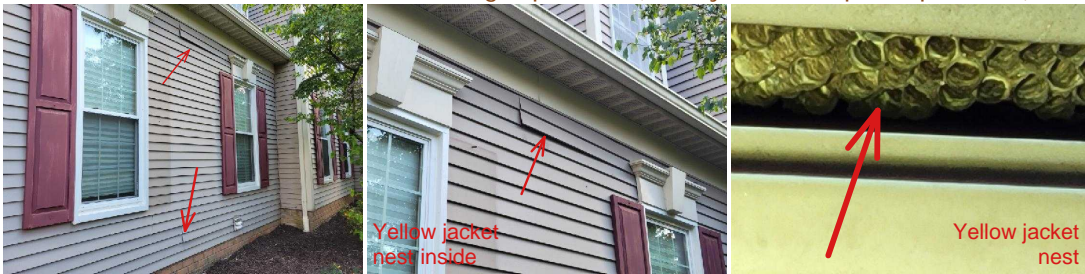
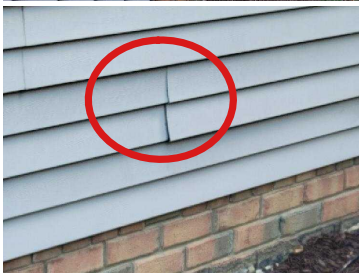
5. Minor Siding: Aluminum siding - Recommend handyman repair loose siding shown. A yellow jacket nest was inside the upper siding piece so a specialist may be required to remove the nest and its habitants first and then have the siding repaired. (Handyman and pest specialist)

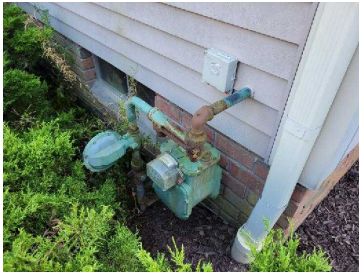
- 8. Acceptable Exterior Electric Outlets: 110 VAC GFCI
- 9. Acceptable Hose Bibs: Gate-frost free type
- 10. Maintenance Gas Meter: Exterior surface mount at left side of home - **Clear out vegetation all around the meter.**

2. Gas Meter: Exterior surface mount at left side of home - **Clear out vegetation all around the meter.**

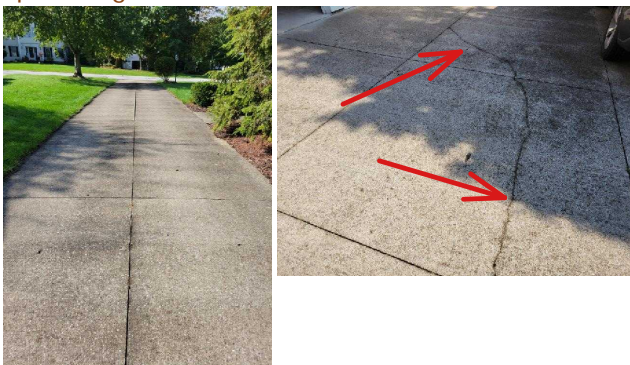
- 1. Minor Driveway: Concrete - Driveway is in great shape from apron to garage. Observed a crack by the doors that can be filled with a good quality filler from a DIY store. This will keep the cracks from spreading and deterioration from the freeze - thaw cycles in the winter.

4. Driveway: Concrete - Driveway is in great shape from apron to garage. Observed a crack by the doors that can be filled with a good quality filler from a DIY store. This will keep the cracks from spreading and deterioration from the freeze - thaw cycles in the winter.

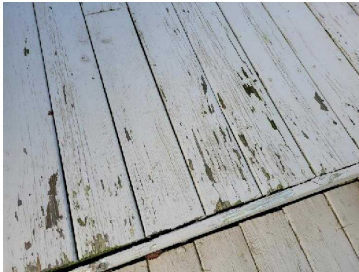
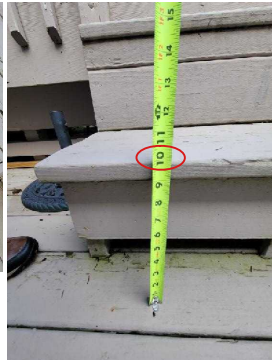
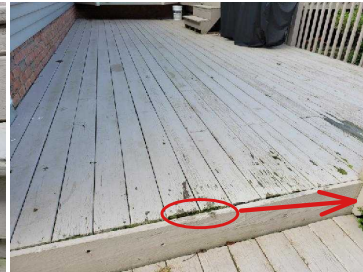
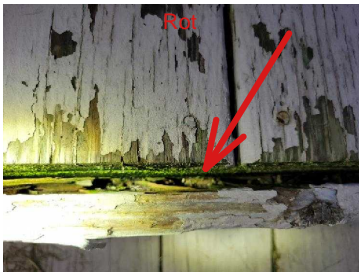
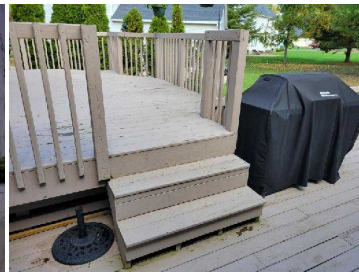
Deck: Stained wood - Consider power washing and staining/painting next season. Steps are a couple inches too high and there are no safety railings present. (Safety item)(Handyman)

1. Deck: Stained wood - Consider power washing and staining/painting next season. Steps are a couple inches too high and there are no safety railings present. (Safety item)(Handyman)

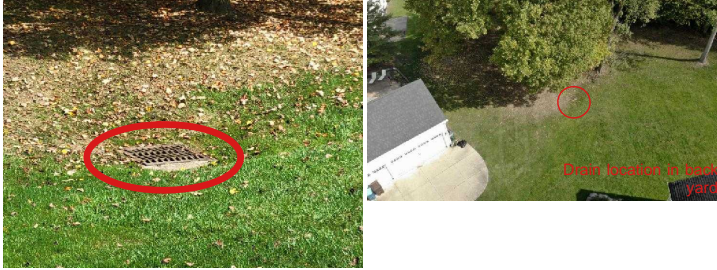
7. Acceptable Lot drainage: Adequate slope and depth for drainage - Low point with drain sewer present this is good!

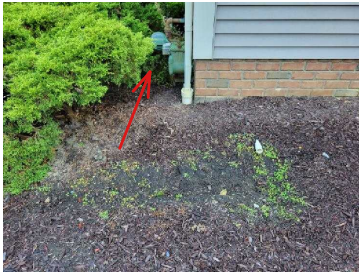
8. Maintenance Vegetation: Trees and shrubs and low vegetation on the perimeter of the home - Trim trees and shrubs away from the structure at least 10-12". Recommend landscape contractor.

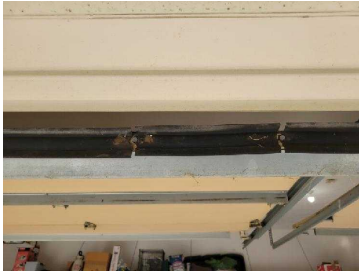
2. Minor Garage Doors: Aluminum - Recommend replacing bottom door seals on both doors that are cracked. (Handyman)

5. Attached Garage Garage Doors: Aluminum - Recommend replacing bottom door seals on both doors that are cracked. (Handyman)
6. Attached Garage Door Openers: Wayne Dalton - Consider changing out the button to a new one that has all of the parts present. (Handyman)
7. Attached Garage Doors and windows: Man door to outside has a lock that is inoperative and the door cannot be locked. Recommend repair or replace. (Handyman)

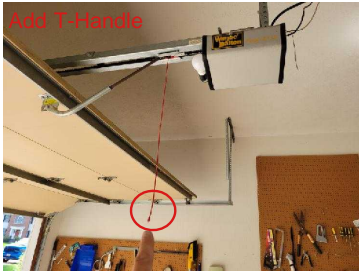
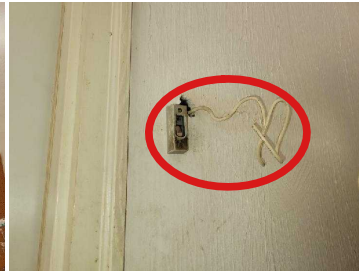
3. Minor Door Openers: Wayne Dalton - Consider changing out the button to a new one that has all of the parts present. (Handyman)

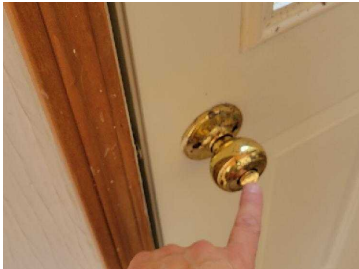
7. Minor Doors and windows: Man door to outside has a lock that is inoperative and the door cannot be locked. Recommend repair or replace. (Handyman)

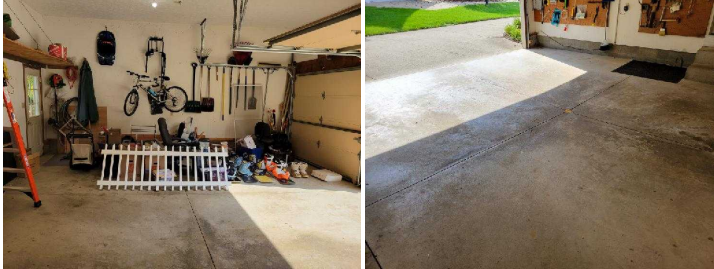
8. Acceptable Ceiling, walls, and floor: Stored items in garage shown prevented full visibility of walls and floor.

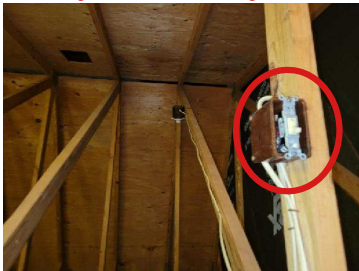
9. Major Electrical: 110 VAC GFCI - Replace switch cover to switch located in the attic space above garage. (Safety item) (Handyman)

2. Attached Garage Electrical: 110 VAC GFCI - Replace switch cover to switch located in the attic space above garage. (Safety item) (Handyman)

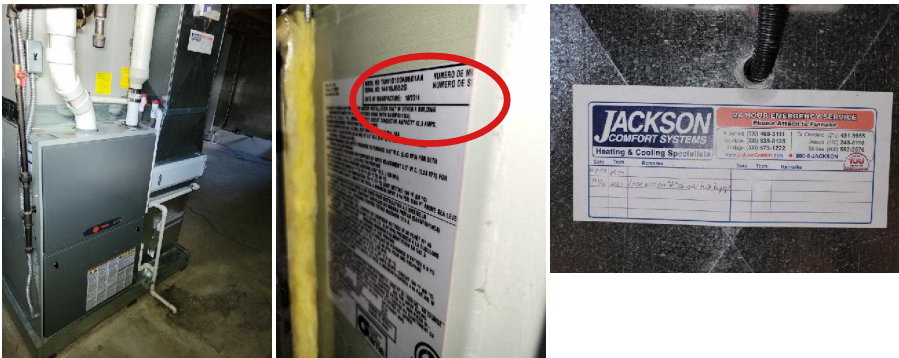
1. Maintenance Heating System Operation: Functional the day of the inspection - Working fine today. Recommend a licensed HVAC contractor tune-up as the last service on the service tag was 5 years ago.
2. Manufacturer: Trane

6. Basement Heating System Heating System Operation: Functional the day of the inspection - **Working fine today. Recommend a licensed HVAC contractor tune-up as the last service on the service tag was 5 years ago.**
7. Basement Heating System Filter: Aprilaire - **Change filter after you are done moving in. It's due.**
8. Basement Heating System Humidifier: April-Aire - **Did not come on when tested. Recommend a licensed HVAC contractor repair and change out the water panel pad.**

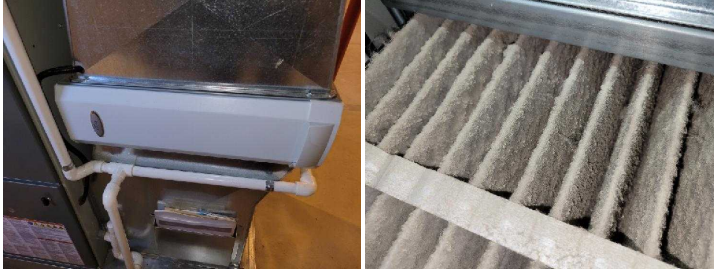
8. Maintenance Filter: Aprilaire - **Change filter after you are done moving in. It's due.**

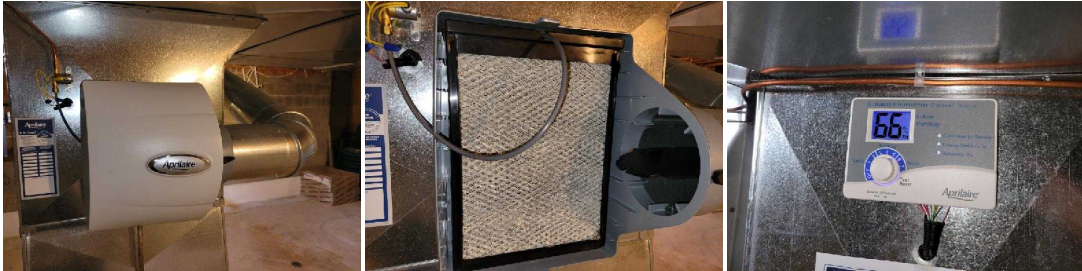
13. Maintenance Humidifier: April-Aire - **Did not come on when tested. Recommend a licensed HVAC contractor repair and change out the water panel pad.**

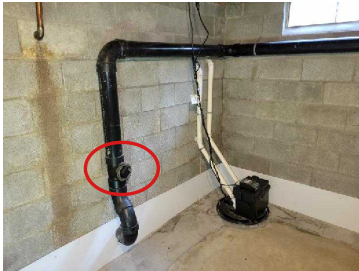
- 3. Acceptable Water Lines: Copper
- 4. Acceptable Drain Pipes: ABS/PVC
- 5. Acceptable Service Caps: Accessible-basement cleanout shown - Sewer scope was run out to 75 feet. Clean PVC SDR pipe all the way out was observed. No action required.

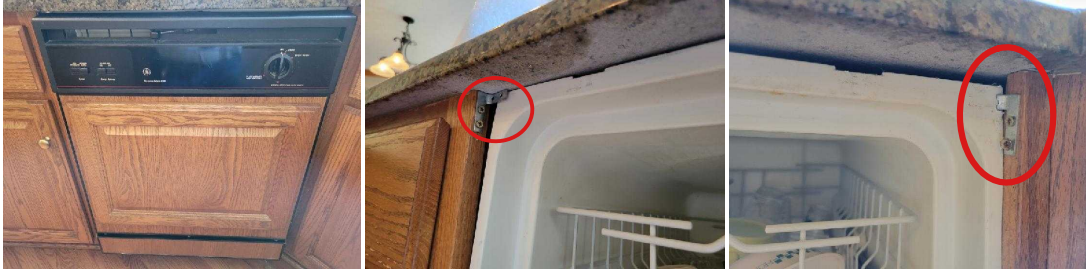
Dishwasher: General Electric - Properly secure to counter/base cabinets. (Handyman)

8. 1st Floor Kitchen Dishwasher: General Electric - Properly secure to counter/base cabinets. (Handyman)
9. 1st Floor Kitchen Sink plumbing: Spray hose has kinked hose at bottom as shown and should be replaced. The counter weight can then be repositioned so it will suck the hose up into the receiver better than it does now. (Licensed plumber)

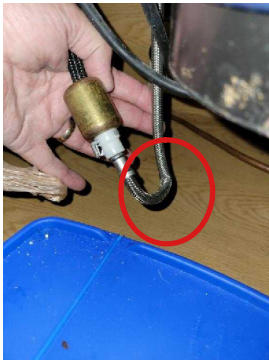
Sink plumbing: Spray hose has kinked hose at bottom as shown and should be replaced. The counter weight can then be repositioned so it will suck the hose up into the receiver better than it does now. (Licensed plumber)

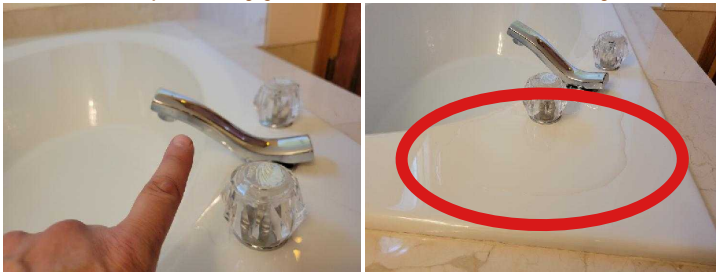
- 1. Acceptable Walls, ceiling and floor:
- 2. Acceptable Doors and windows:
- 3. Acceptable Electrical: 110 VAC GFCI
- 4. Acceptable Counter/Cabinet:
- 5. Acceptable Sinks, hot/cold water, drains:
- 6. Minor Tubs, hot/cold water, drains: When both hot and cold are turned on the aereator shoots the water to the rear. It probably just needs cleaned. (Handyman)

10. All unless otherwise noted Bathroom Tubs, hot/cold water, drains: When both hot and cold are turned on the aereator shoots the water to the rear. It probably just needs cleaned. (Handyman)
11. All unless otherwise noted Bathroom Toilets: The toilet is loose at the floor (front right bedroom bathroom) and will require seal replacement and reinstallation. Fill valve needs replaced as it is spraying water out of the top seal area. (Licensed plumber)

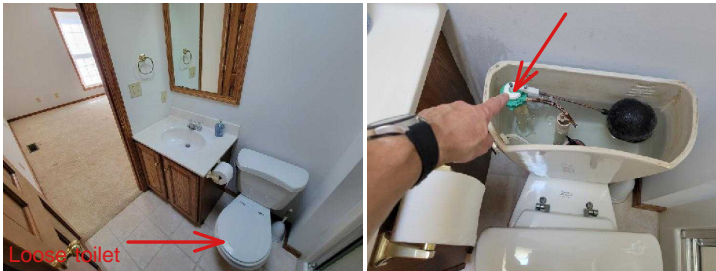
- 7. Acceptable Showers, hot/cold water, drains:
- 8. Not Present Jacuzzi, hot/cold water, drains:
- 9. Minor Toilets: The toilet is loose at the floor (front right bedroom bathroom) and will require seal replacement and reinstallation. Fill valve needs replaced as it is spraying water out of the top seal area. (Licensed plumber)

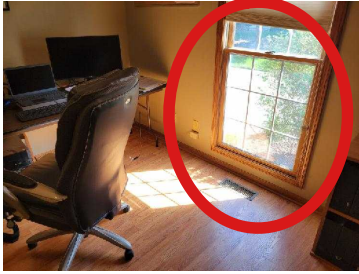
2. Major Doors, windows and trim: **Window in first floor office will not stay up and is a safety hazard. Use caution raising and lowering the window until it get repaired or replaced. (Safety item) (Handyman)**

3. All unless noted otherwise Living Space Doors, windows and trim: Window in first floor office will not stay up and is a safety hazard. Use caution raising and lowering the window until it get repaired or replaced. (Safety item) (Handyman)
4. All unless noted otherwise Living Space Smoke Detector: Hard wired - Replace any unit over 10 years old even if they test ok as the sensors become unreliable. (Safety item)

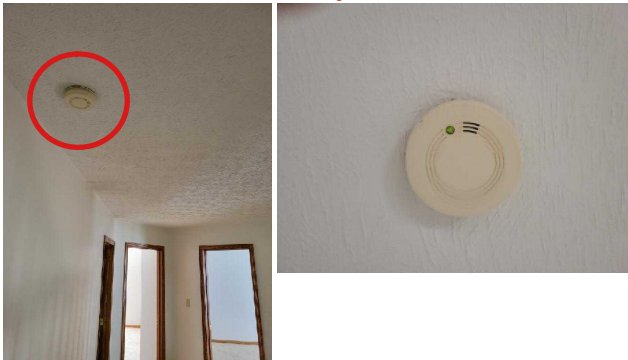
8. Major Smoke Detector: Hard wired - **Replace any unit over 10 years old even if they test ok as the sensors become unreliable. (Safety item)**

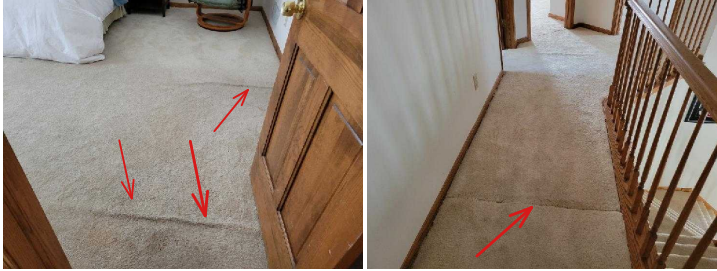
- 1. Acceptable Closet:
- 2. Minor Ceiling, walls and floor: Carpet burps and seams can be corrected by a carpet professional. The carpet appears to have little wear. Recommend having it stretched and then steam cleaned. Much less cost than replacing it!

12. All unless noted otherwise Bedroom Ceiling, walls and floor: Carpet burps and seams can be corrected by a carpet professional. The carpet appears to have little wear. Recommend having it stretched and then steam cleaned. Much less cost than replacing it!

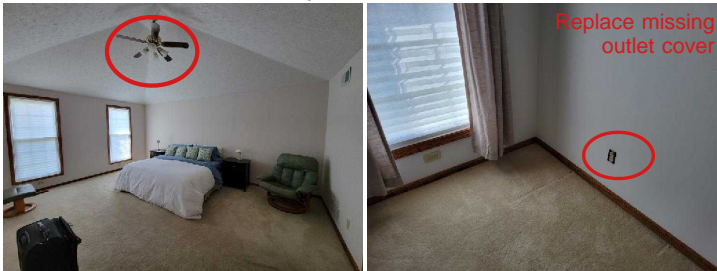
- 3. Acceptable Doors and windows:
- 4. Major Electrical: 110 VAC - Replace switch cover shown in bedroom. (Safety item)

5. All unless noted otherwise Bedroom Electrical: 110 VAC - Replace switch cover shown in bedroom. (Safety item)

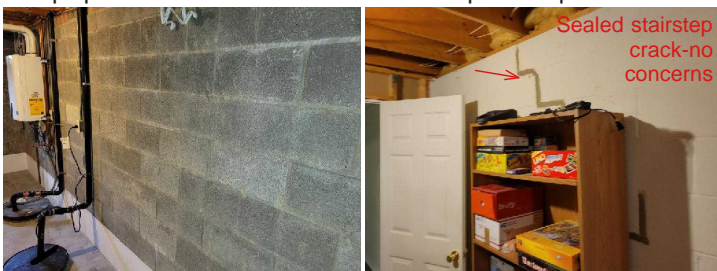
- 1. Acceptable Structure Type: Wood frame
- 2. Acceptable Foundation: Block - Observed one short stair step crack in the foundation block that was filled. Otherwise the foundation looks stellar! Owner reports basement water proofing was done so ask for the paperwork as most of these companies pass the warranties on to future owners.

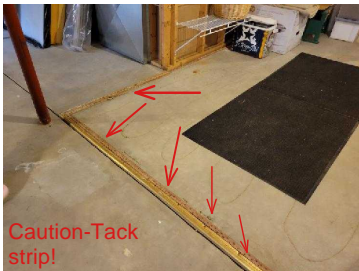
- 1. Acceptable Unable to Inspect: 25%
- 2. Acceptable Ceiling: Exposed framing and suspended ceiling
- 3. Acceptable Walls: Foundation block and finished off-drywalled
- 4. Major Floor: Poured - **Cover or remove tack strips in basement. (Safety item) (Handyman)**

6. Main Basement Floor: Poured - Cover or remove tack strips in basement. (Safety item) (Handyman)
7. Main Basement Electrical: 110 VAC - Light fixture shown is hanging by its power wires and should be resecured. (Licensed electrician)

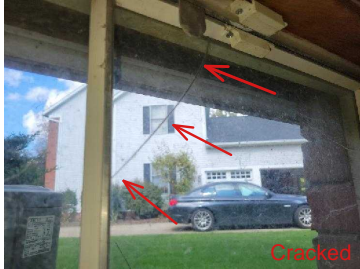
7. Minor Windows: Single pane-metal frame - Cracked glass on basement window shown. Recommend reputable contractor quote on repair/replace.

13. Main Basement Windows: Single pane-metal frame - Cracked glass on basement window shown. Recommend reputable contractor quote on repair/replace.

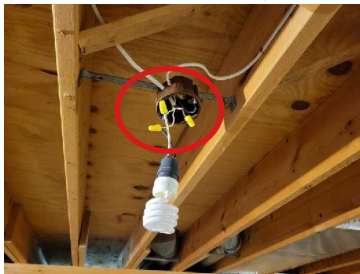
8. Major Electrical: 110 VAC - Light fixture shown is hanging by its power wires and should be resecured. (Licensed electrician)

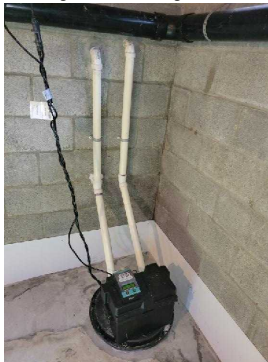
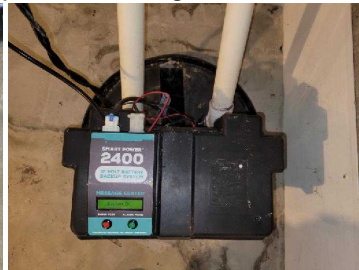
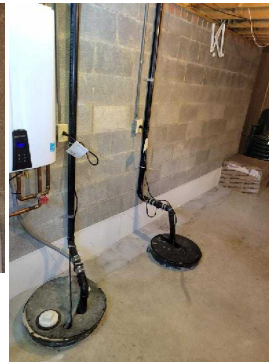
9. Acceptable HVAC Source: Heating system register
10. Not Present Vapor Barrier:
11. Not Present Insulation:
12. Acceptable Ventilation: Windows
13. Acceptable Sump Pump: Three sump pump crocks installed - Pumps were cycled and found to be functional today. Battery backup on front single crock was installed and tested functioning fine today.
